WINTER 2005

Flight Comment

THE CANADIAN FORCES FLIGHT SAFETY MAGAZINE

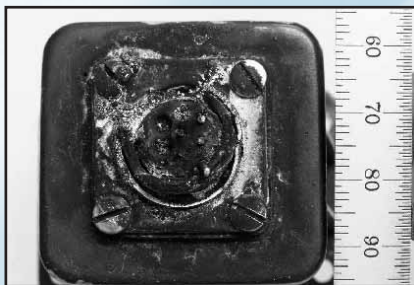
Relay end of the connector showing the damage to the three phase pins and the melted connector case.

On 18 February 2002, a fire onboard a *Labrador* helicopter CH113304 was initiated at an electrical connector. One possible cause identified by the Quality Engineering Test Establishment (QETE) was that the blank/empty pinholes in the connector possibly allowed pin movement and shorting. The connector was a ten pin connector but only five pins were used, neither the unused pins nor the blanking pins were installed.
